SECTION 1: PROJECT INFORMATION

Library Name: Wheeler Memorial Library Date: 1/19/2017

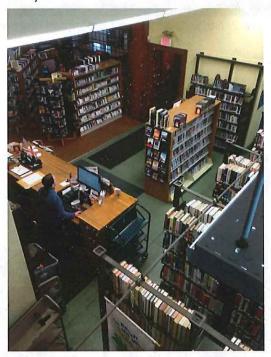
The circulation desk serves as the central location upstairs for borrowing materials, seeking reference help, seeking assistance with library equipment such as the computers and copier, and receiving phone calls. Since the circulation desk is located directly in the direct line of sight from both entrances, it also serves as a counter for small displays and fliers, which often interrupts the flow of incoming and outgoing materials. Work space at the desk is limited, and any projects staff engage in at the desk need to be moved out of the way each time a patron brings over materials to return or borrow, which makes accomplishing any substantial work while at the desk difficult. Storage space for supplies and patron holds is limited and inconvenient to the point where it is almost impossible for two staff members to work at the desk simultaneously.

Figure 1 Half of the circulation desk is devoted to displays

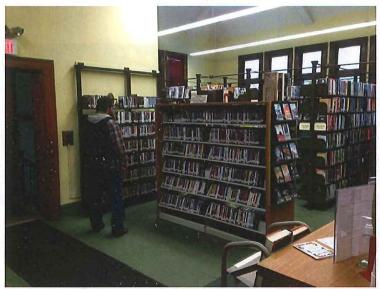
Figure 4: DVDs are conveniently located close to the desk, but block access to the stacks

Every usable room in the library has been utilized in some way to house its ever-expanding collections. The DVDs are located on a free-standing shelf closest to the side stairwell, in an effort to accommodate patrons who have difficulty with the narrower stacks. (See figure 4 above)

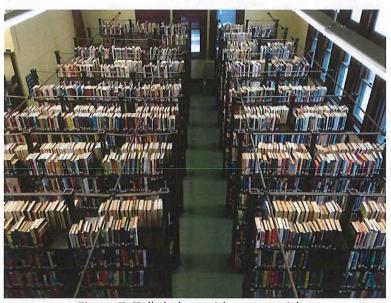
In the fiction and non-fiction area, the nearly 6'6" shelves make it difficult for both patrons and staff to safely retrieve books, and narrow aisles prevent more than one person from browsing an area at a time. Both fiction and non-fiction are chronically overcrowded, and these collections are weeded aggressively to make room for newer acquisitions. There is no space among the stacks or along their edges to stop or read, and borrowers looking to take more than a few books at a time will often leave their selections at the circulation desk while they continue to browse.

Figure 7: Tall shelves with narrow aisles

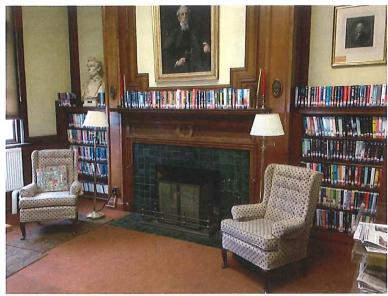
Figure 15: Cozy spaces to sit, but not much space to browse the shelves.

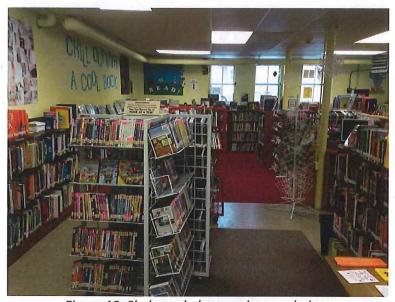
Figure 19: Shelves, shelves, and more shelves

One of the most difficult aspects of this room is the presence of built-in, non-adjustable shelving units the total length of the wall space. One section has been modified to be adjustable but the majority of the shelves are no more than 9" high, making it hard to shelve the many large or unusual-sized books in the collection. It is also not possible to rearrange shelving units to create new spaces or adapt units to new formats as they become available. A few old wooden bookcases, removed from the meeting room during its renovation, have been painted and added to the room to provide much-needed shelf space, and wire shelves have been fit in everywhere possible.

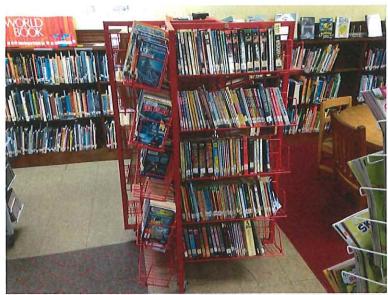
Figure 20: The wire shelves are bright, cheerful colors, but they're also in the middle of the floor

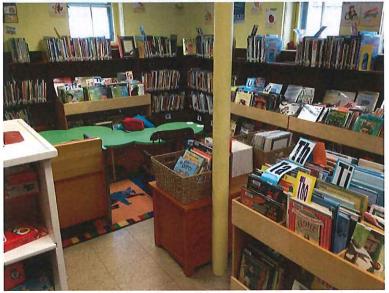
Figure 21: Child-friendly, well labeled, and very crowded

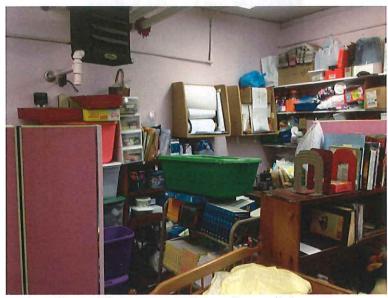
Figure 24: So many craft supplies, so little space

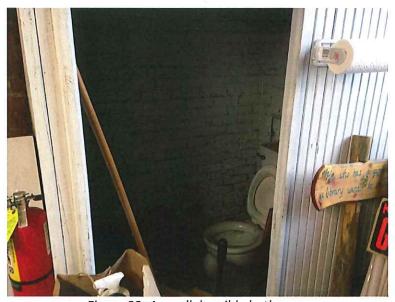
There are some who might argue that the library has two bathrooms, but the toilet located in the mechanical room makes the upstairs bathroom seem luxurious. The stall in the mechanical room has no door, no light and extremely questionable plumbing. Anyone flushing the toilet stands a good chance of flooding the floor, either from a leak in the pipes or an overflow.

Figure 32: A small, horrible bathroom

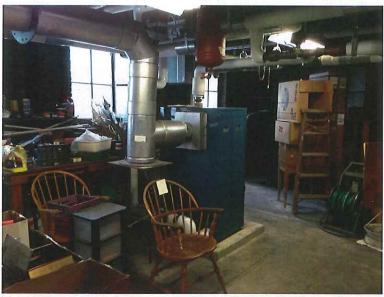
The space around the boiler and the oil tanks is also cause for concern; the mechanical room is frequently used as a storage area, and well-meaning volunteers sometimes unintentionally violate the fire code by placing combustible materials too close to the tanks or pipes. Ideally, not cardboard or wood should be in the mechanical room, but conditions at Wheeler are not ideal, so we simply do our best to comply with fire code.

Figure 38: Combustible wood and cardboard items left too close to the boiler and the oil tanks at the rear

A dedicated server room and updated wiring will eliminate our electrical hazards and ensure that everything installed is up to code. Having separate rooms for storage, the mechanical room, and the systems room will also eliminate the fire hazards faced in the current mechanical room. In the event of a fire, the public will not be required to run up staircases or climb out of windows. On the ground floor there are several exits available. The side and front doors of the current building, although not ADA-compliant, will be kept as emergency exits, and both the main entrance and the community room exit directly into the parking lot. The children's room upstairs has an emergency staircase that leads out onto the side lawn, and the basement area has an emergency exit that leads out onto the front lawn.

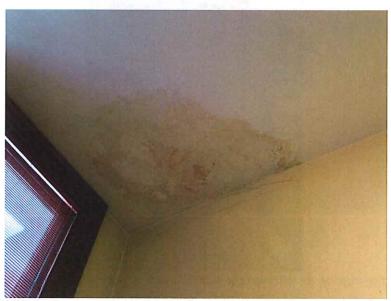
The staff workroom is also a frequent victim of roof leaks. Water stains from a previous leak in the corner are still highly noticeable. The threat of future water damage in this room is escalated by the fact that it houses the server, routers, two staff computers, a wired smoke detector, and the staff microwave and mini fridge.

Figure 45: The room with the highest concentration of electronic equipment showing signs of water damage

The renovated building will be brought up to code, and the renovations will include a new roof. The past 102 years have proven that the current roof is not structurally sound and needs to be replaced. While it is highly unlikely that the basement will ever be completely waterproofed, given the nature of the land the library was built on, with modern improvements it can easily be made into a comfortable space for staff use and storage.

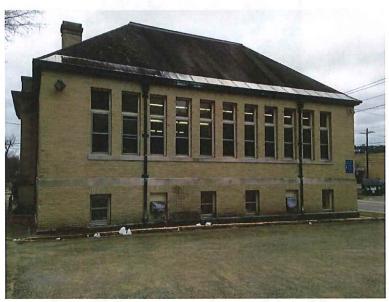
There is no entrance available directly from the library parking lot. Patrons must either walk along the side of the building to the side entrance, or walk around the building to the front entrance. The sidewalks and paved parking area can be dangerous in the winter and during heavy rains.

Figure 56: No entrance at the rear of the building

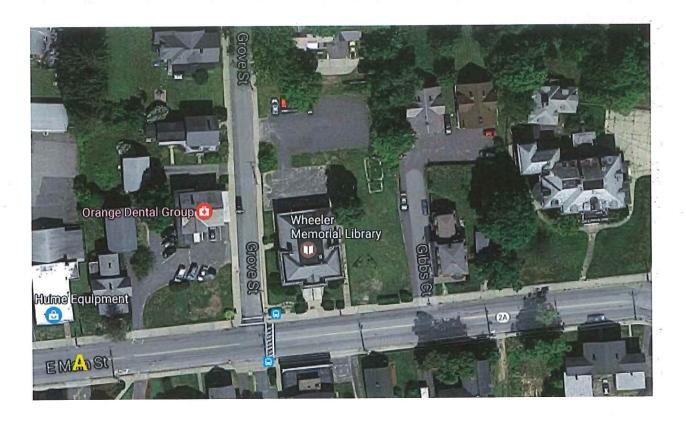
The library currently has 27 dedicated parking spaces in the rear of the building, in two adjoining lots. In figure A, the current parking configuration is shown.

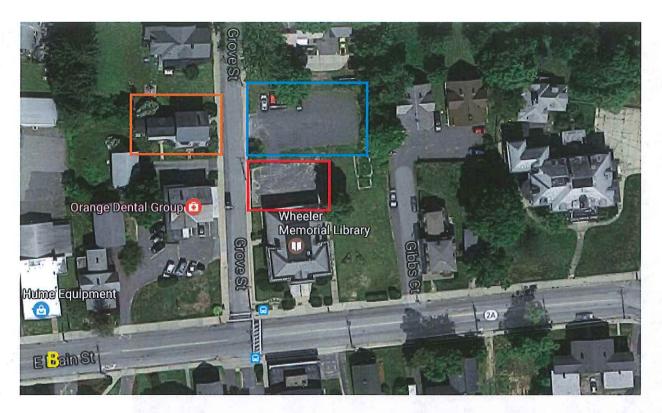
For the renovation, the lower, paved parking area will be destroyed to create space for the rear addition. This area is marked in red in figure B. The remaining parking space, marked in blue, will be paved and remodeled to have 23 parking spaces, including 2 handicapped spaces. The proposed renovation is 20,062 square feet; the current parking does not meet the MBLC guideline of one parking space per 400 gross square feet of building, which would be 51 spaces, not including staff parking.
